6  
AERIAL PHOTOINTERPRETATION  
OF A SMALL ICE JAM.

10  
Stephen L. DenHartog

11  
Oct 1977

20. ABSTRACT (Continue on reverse side if necessary and identify by block number) Aerial photos of a small ice jam on the Pemigewasett River near Plymouth, New Hampshire, were taken three days after the jam and compared with photos taken after the ice went out. The winter photos show a marked and sudden decrease in floe size apparently indicative of faster and longer movement of the ice. The spring photos show a number of shallows and obstructions that apparently had no effect on the ice movement. It is concluded that this jam was caused by a change in slope and subsequent reduction in velocity.

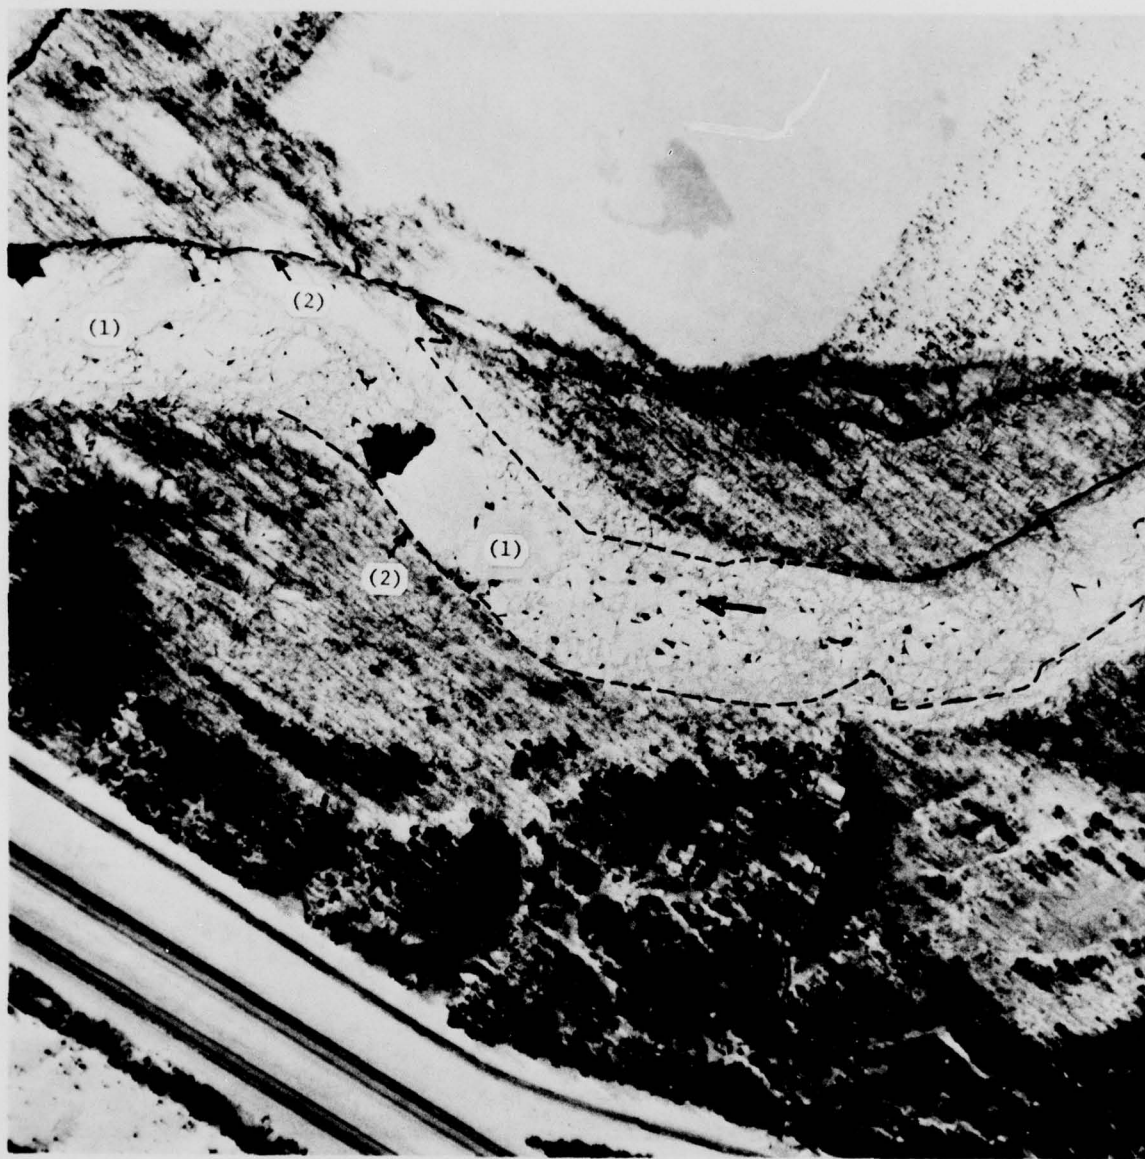
Figure 2a shows a reach of the river below the jam. High water had lifted the ice but the ice had not moved very far downstream. This is evidenced by the large size of the ice pans (1) and the fact that some of the larger pieces are still fixed to the bank (2). The inked dashed lines indicate the shoreline of 30 April when water level was low, probably close to midwinter level. It is interesting to note on Figure 2a and 3a that the large rock outcrop shown by the bump on the east (lower) bank had little apparent effect on the ice movement. The left (downstream) side of Figure 2b shows the same characteristics as Figure 2a but the right side of the photo has a different character shown in the finer texture of the ice blocks. The largest blocks were generally no more than 10% of the width of the river. The matrix is seen to be much darker in tone as a result of its greater relief, which can be readily seen in stereo. The ice in this reach had moved some distance as evidenced by the shear line (3) along the west bank that is seen in both Figures 2b and 2c. but since some large ice pans were still present in this reach, the ice could not have moved very fast and probably not very far.

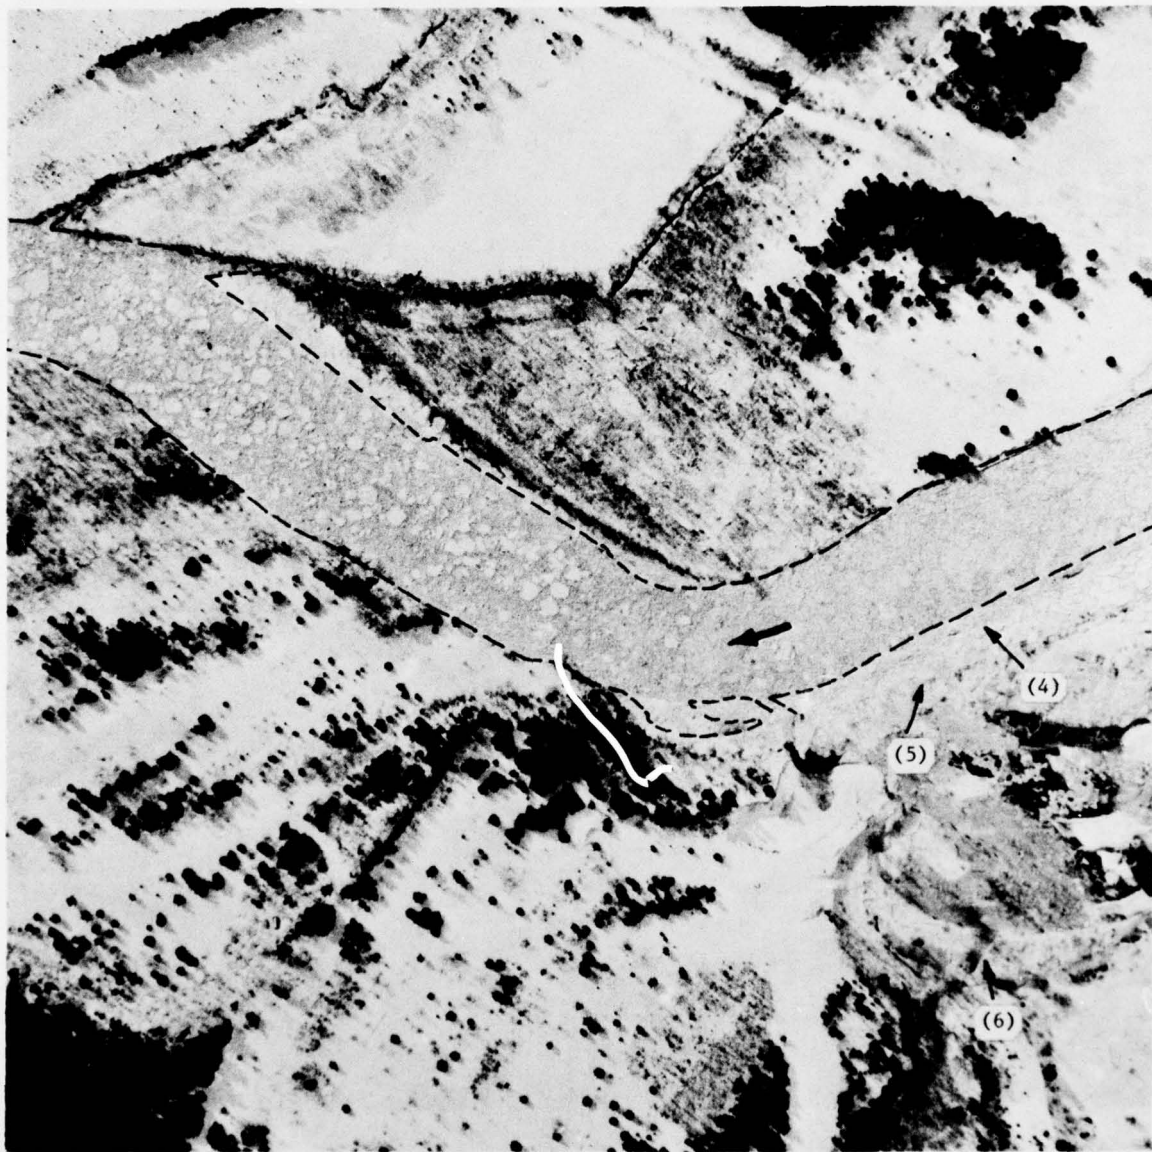
c

The right hand (upstream) portion of Figure 2c shows a third character. The entire river surface was covered with smaller pieces of broken ice having the same character and texture as the matrix in the reach downstream. Few of the pieces here were over 2 ft in their longest apparent dimension. A well-developed shear wall (4) was present on the east bank. On the surface of the shelf of shore ice (5) were larger pieces of ice that were broken loose with the initial rise in water level but which were stranded and not incorporated into the ice run. Spring Brook (6) joins the Pemigewasset from the east just upstream of the bend in the lower side of the photo. The gravel bar described by Smith in 1969 barely showed in the April photography (Fig. 3b) and does not seem to have affected this jam. The gradual transition of the texture and form of the ice cover as it is traced upstream indicates that this jam was caused by a change in surface slope and subsequent reduction in velocity.

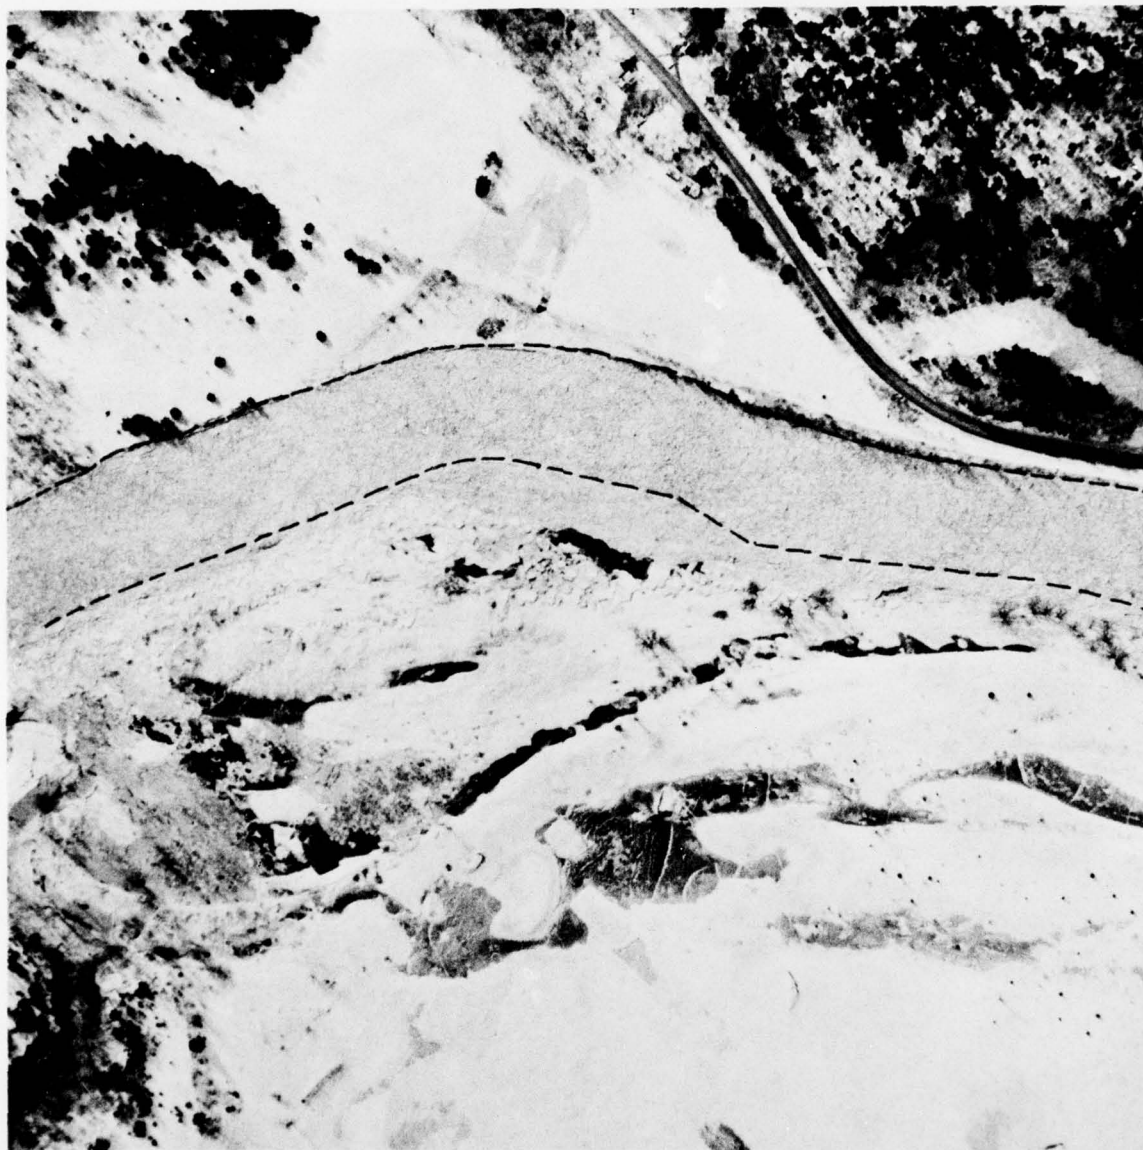
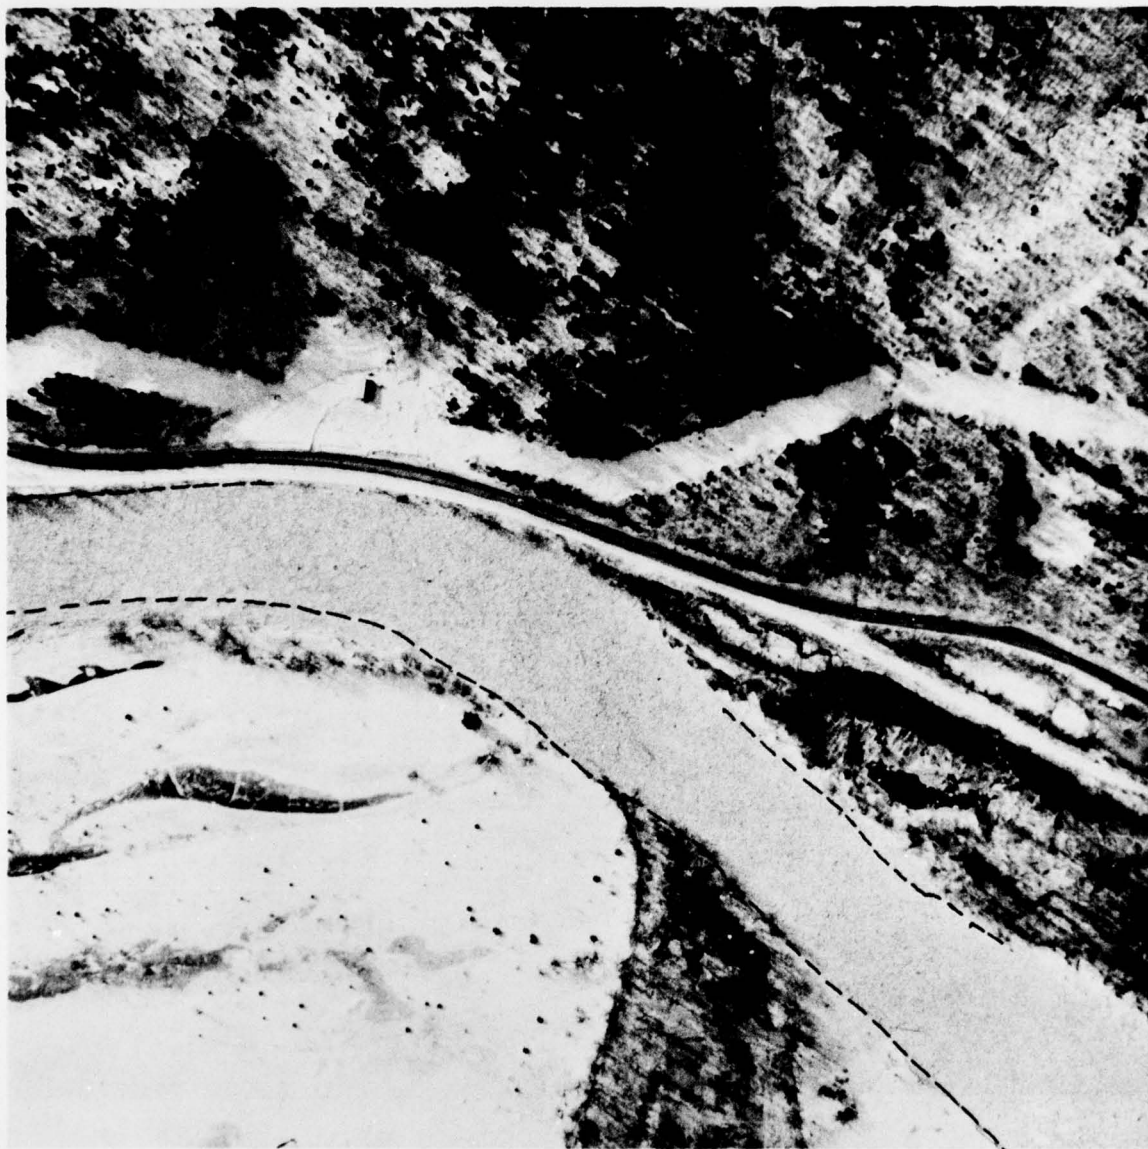
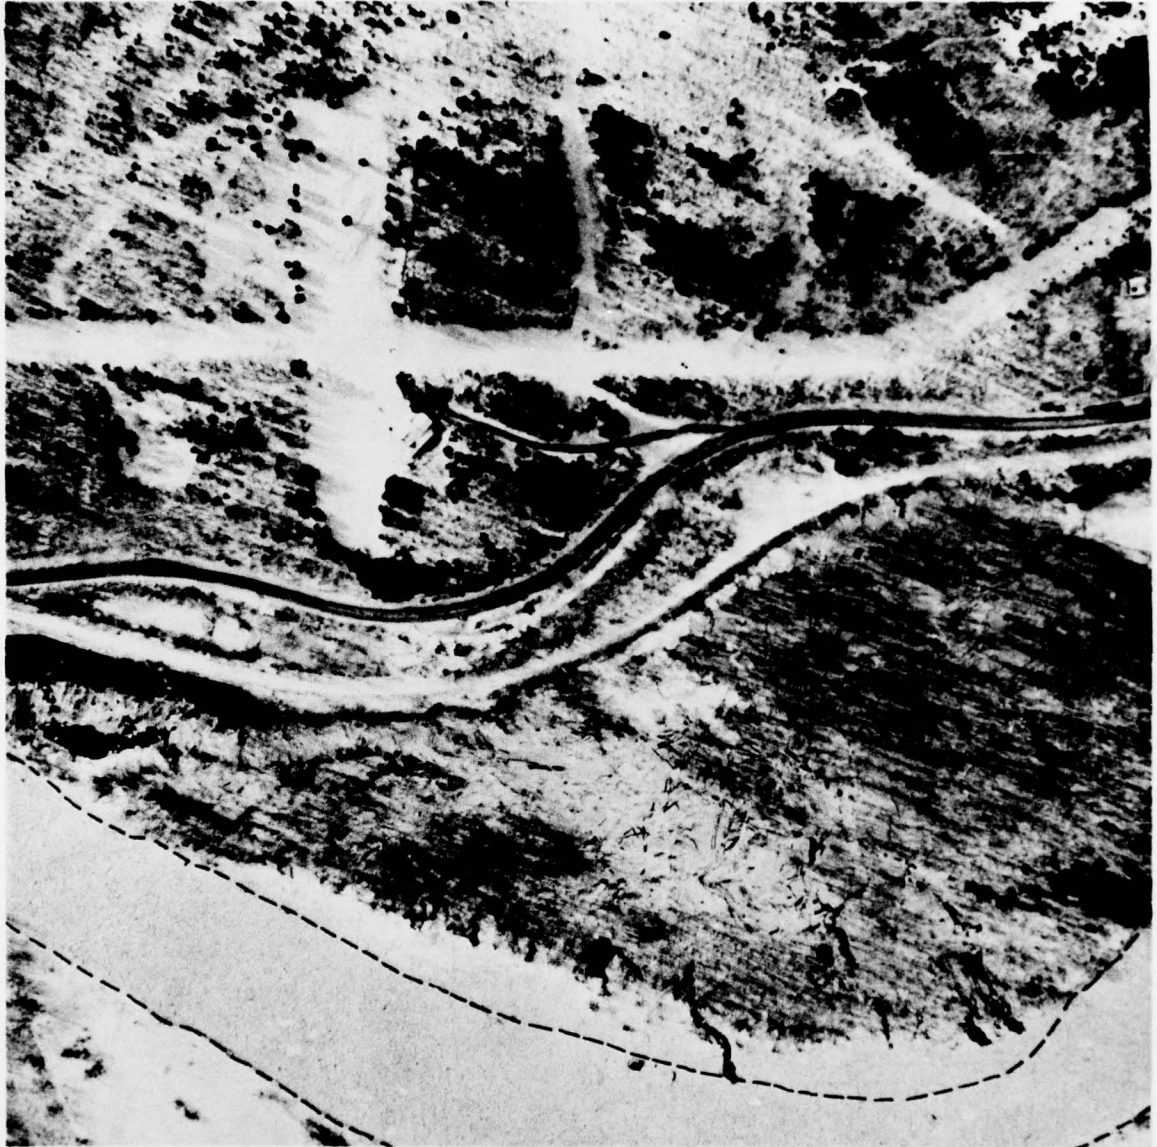
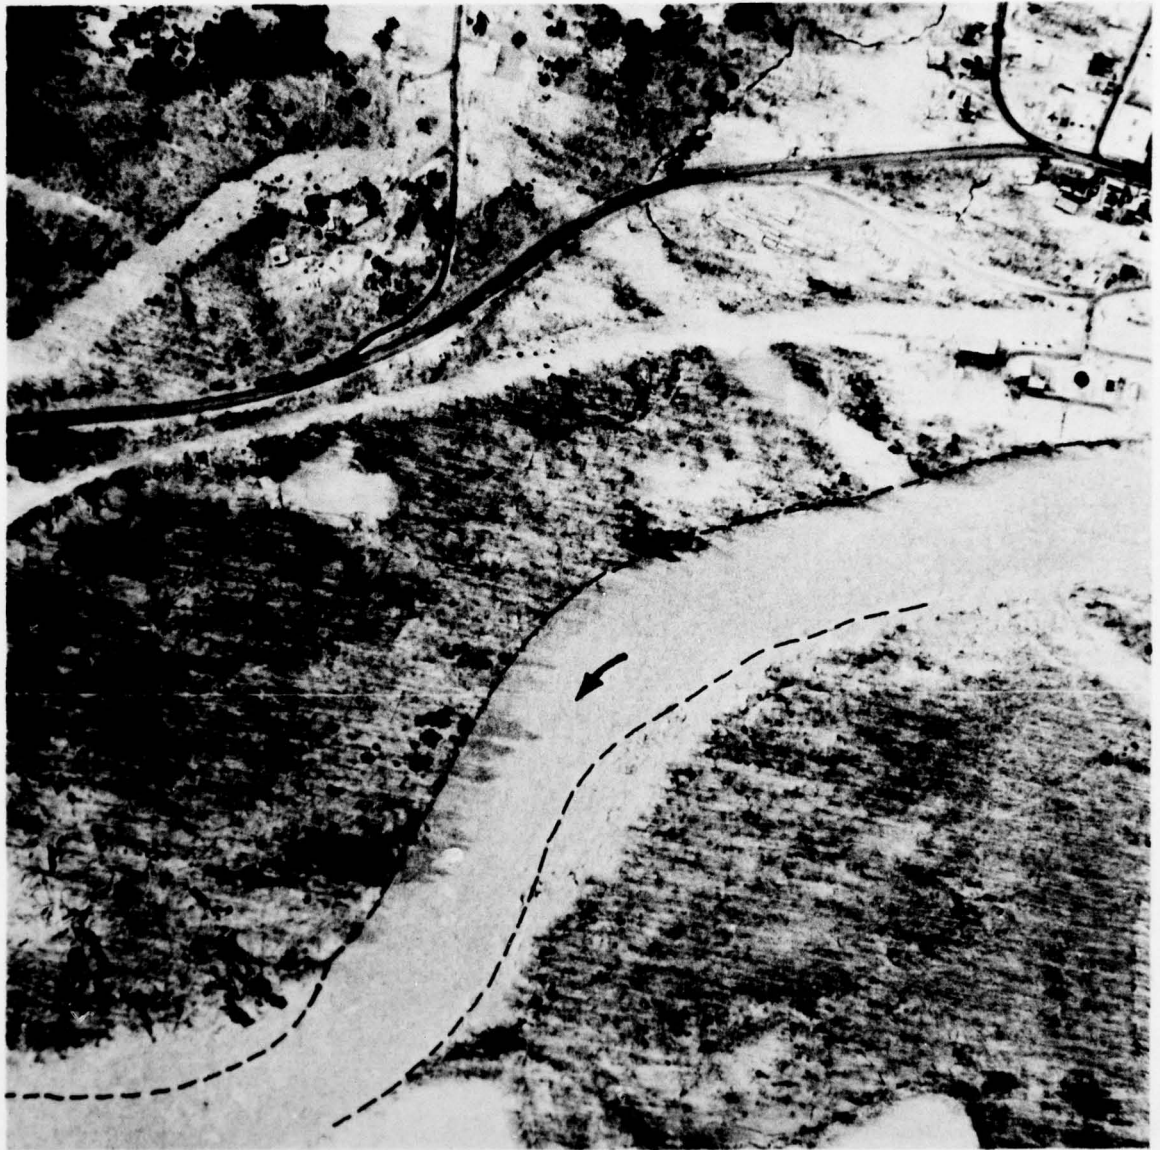
Figures 2d-2g are included merely to show the length of the jam. They all show the typical rough surface of an ice jam, some shear lines near shore and towards the upstream end, and the inclusion of a few larger pans.

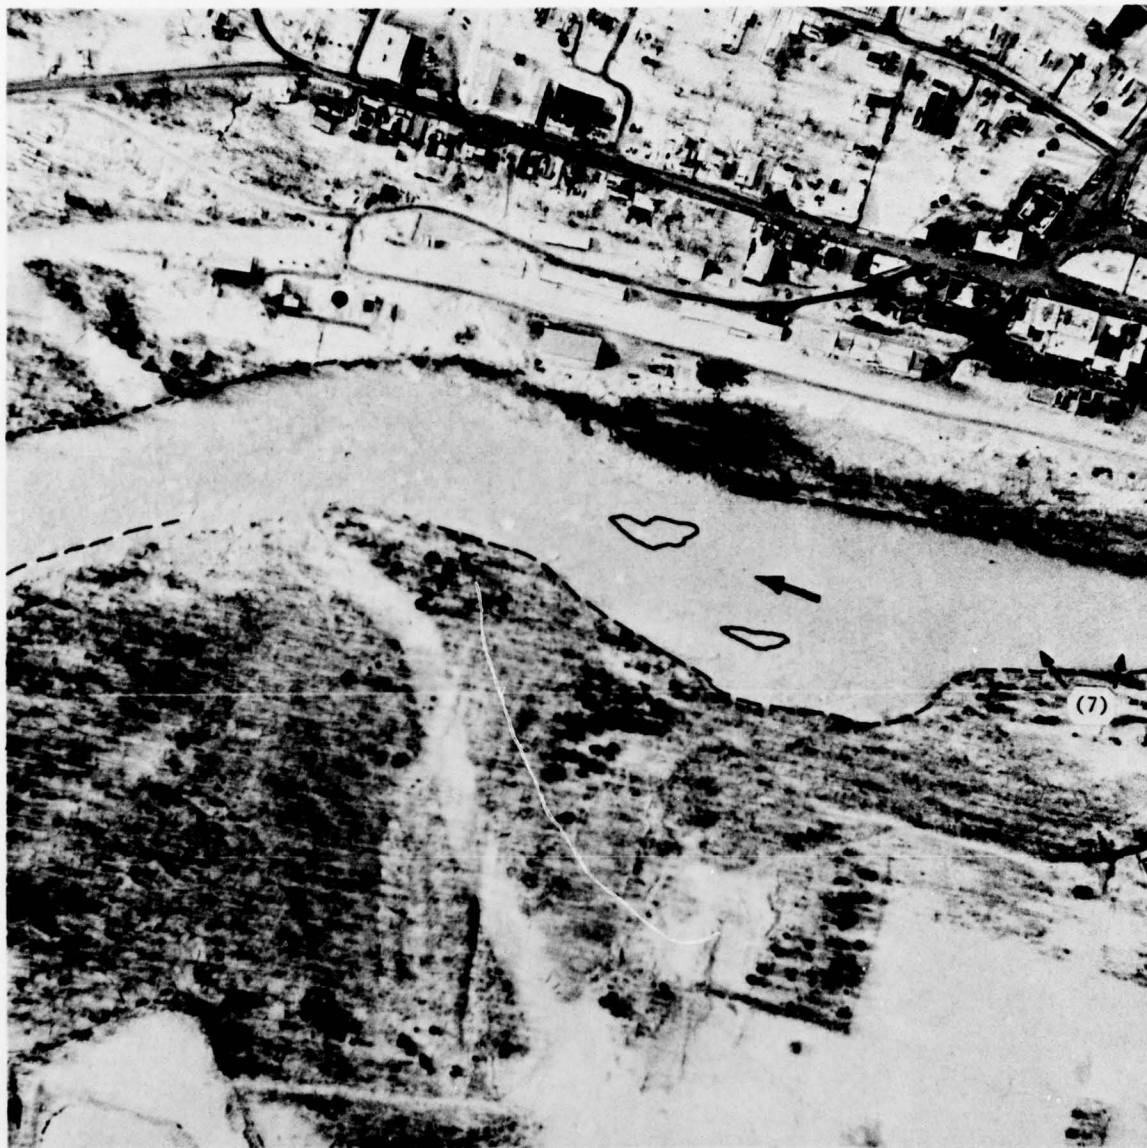
h

Figure 2h shows the upstream end of the jam and no indication of the bars and shallows that are so prominent on the 30 April photos. When observed from the bridge three days before the winter photos were taken (Fig. 3a, b and c), the upstream edge of the ice was nearly at the ridge edge of Figure 2h. Close inspection of this photo and also Figures 2i and 2j shows a number of arcuate ridges (7), concave upstream from the earlier edge of ice upstream to the bridge. Apparently these were formed by the loose, sporadic flow of ice which drifted downstream after the main ice run. By 31 January the weather had cooled and the flow had decreased so underturning of ice blocks and compression of the jams by internal packing was no longer happening.

The pattern in Figures 2h and 2i and the downstream portion of Figure 2j shows this gradual upstream accumulation of ice. The texture is much smoother than that shown of the major part of the jam. The open water areas, though limited, indicate an ice thickness of essentially one layer. Figure 2j shows the confluence of the Baker River (8) with the Pemigewasset (9). The ice in the Baker had not moved, which apparently decreased the severity of this jam. The ice cover on the Pemigewasset from the confluence with the Baker upstream until nearly the edge of the photograph was new ice that had frozen in place since 28 January.

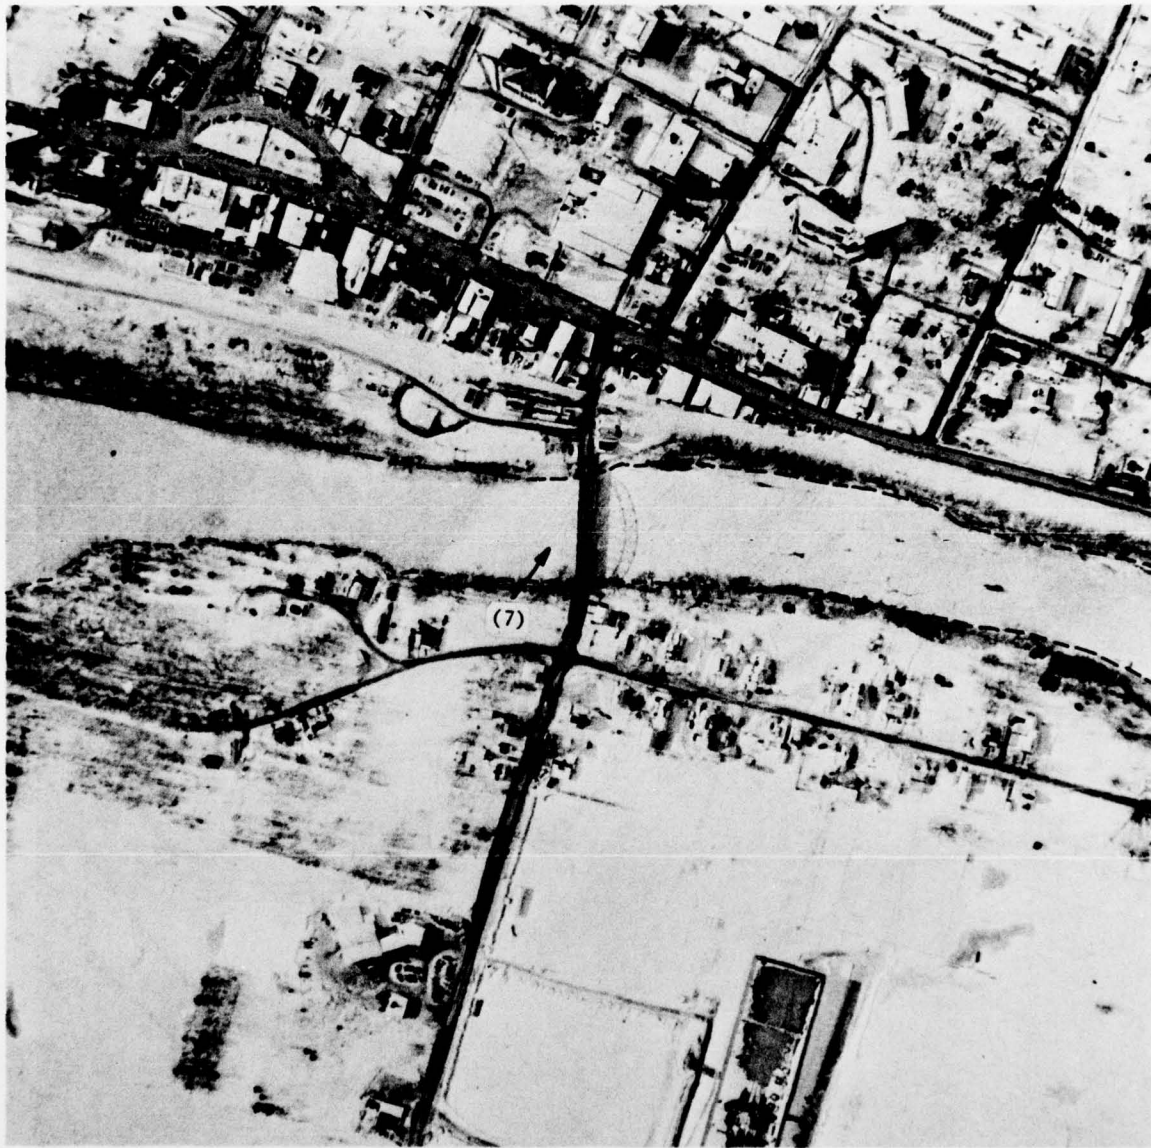
i

Observations on 28 January 1976 showed that no ice movement had occurred at the Route 3 bridge. However, at this time the water was high in Plymouth itself indicating a jam downstream. The river was open from about 100 yards below the highway bridge in Plymouth (Fig. 2i) upstream for an unknown distance, possibly all the way up to Lincoln, New Hampshire, about 20 miles to the north.

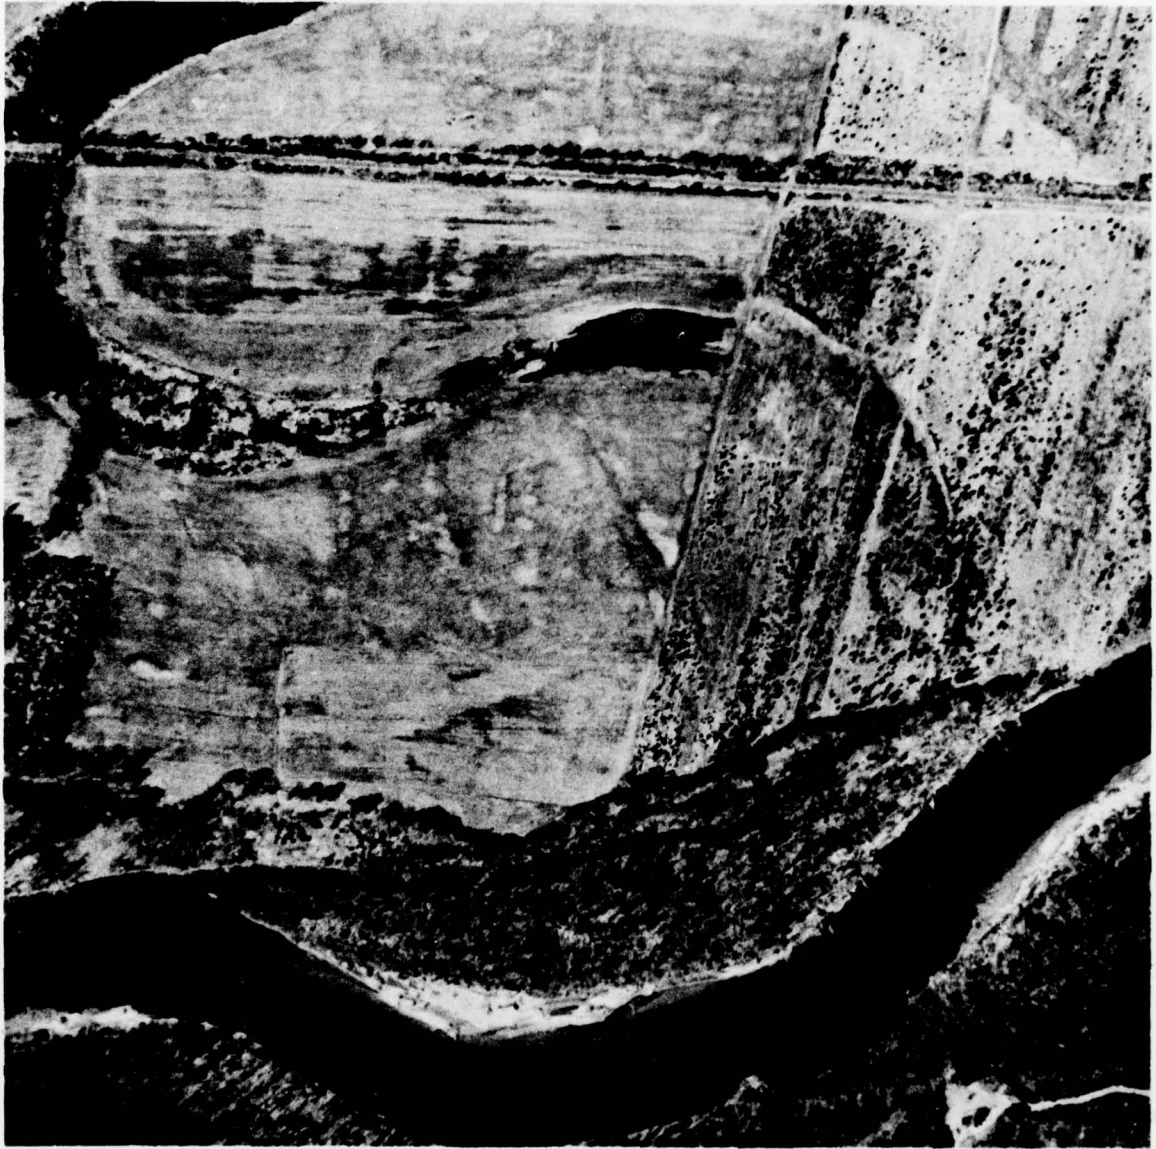
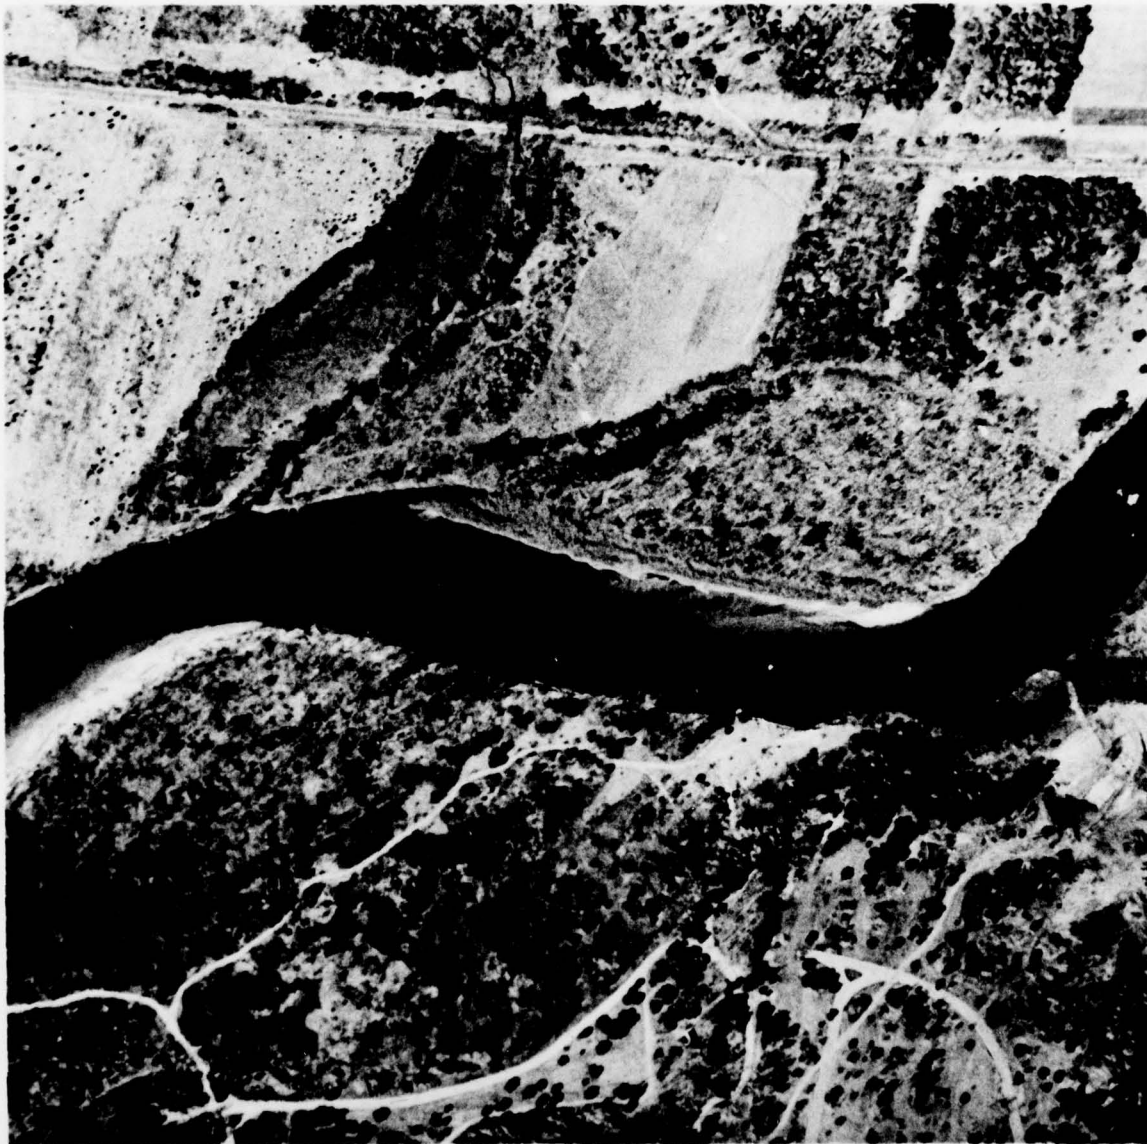
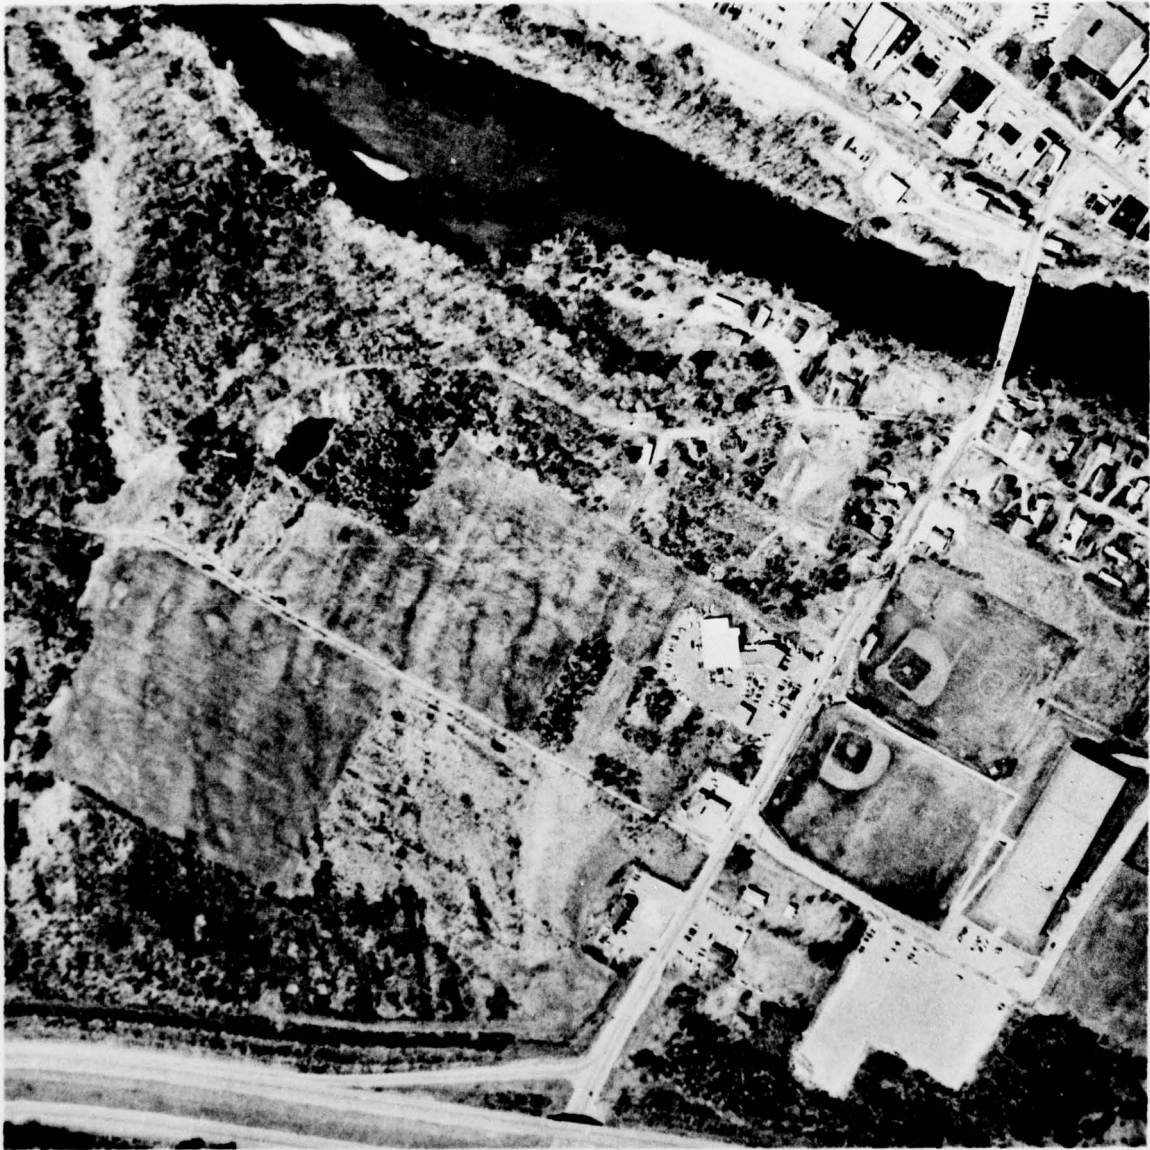
By 30 April all the ice was gone, the water level was fairly low, and the leaves were not yet out. The 30 April photos show the river banks and bars at a level similar to winter conditions. A dashed line on the winter photos depicts the 30 April water line. The sand bars, bends in the channel and constrictions did not cause this jam. How much they contributed to the final location of the foot of the jam by slowing the ice movement is unknown. This jam was caused by the back water from a dam some eight miles downstream.
